The Villas of Park Shore Homeowners Association

September 22, 2023

From the conclusion of the Socotec Engineering report:

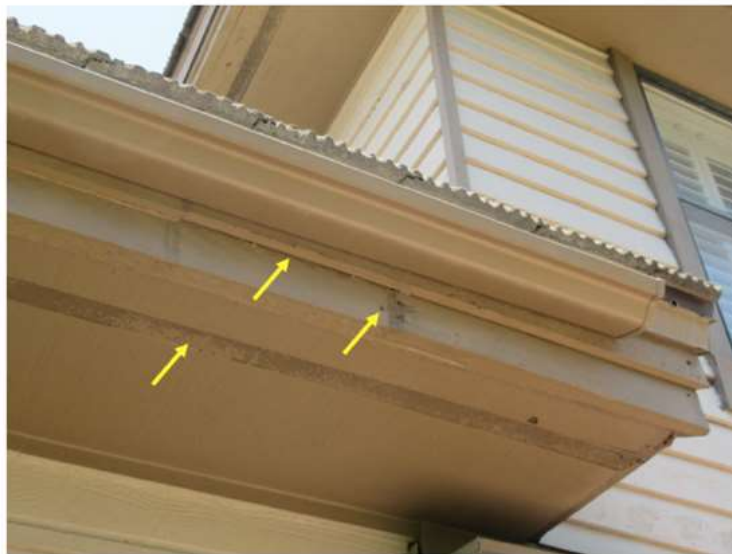
View of typical fascia dry-rot decay and partially sealed soffit vent.

"In addition, we also recommend replacing all the soffit vents, so that the attic space is properly ventilated. Improper ventilation can lead to elevated moisture and interior decay to wood framing, as well as elevated energy costs for cooling the interior spaces of the residences."

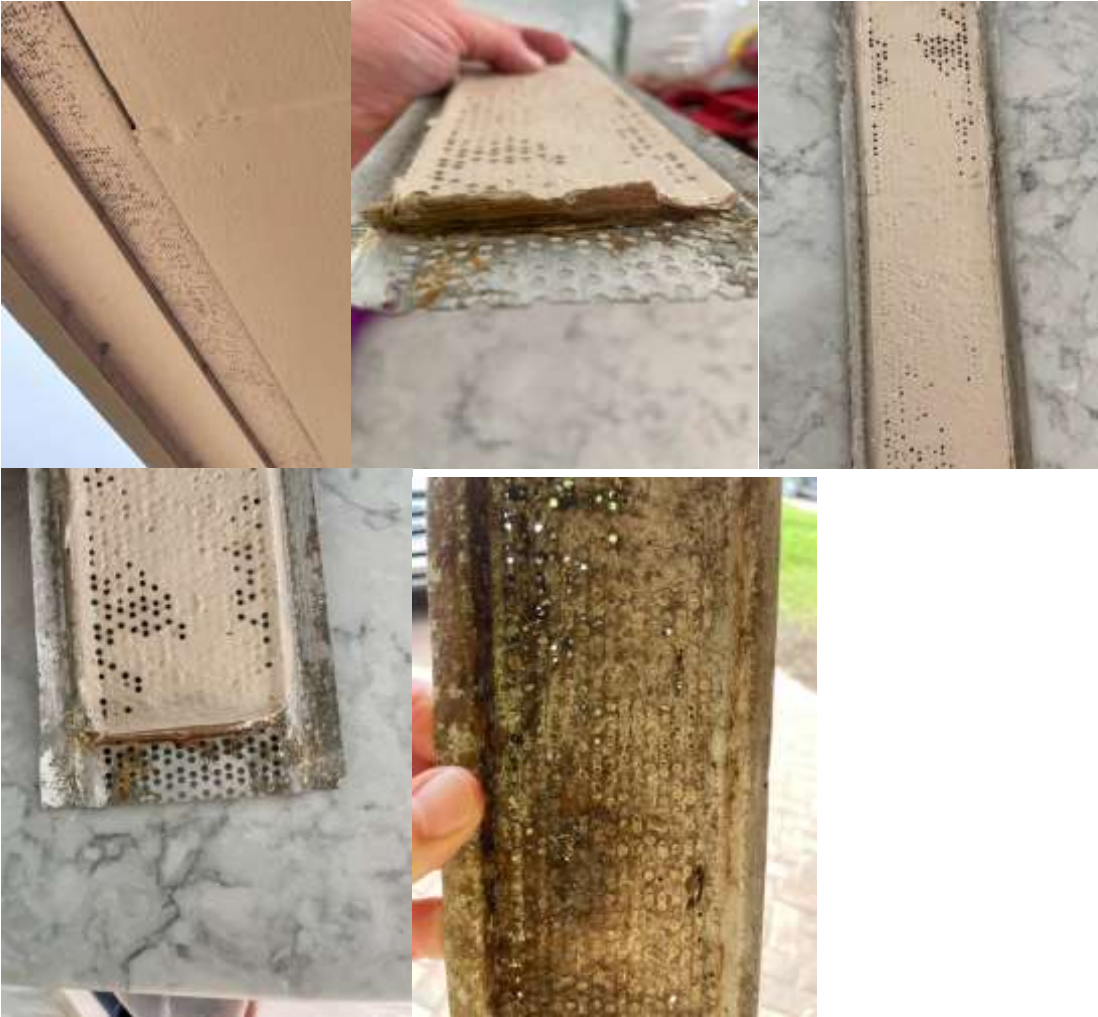
Common soffit vent conditions throughout the community.

Soffit vent replacement materials. Most will need the services of a licensed professional contractor to replace the vents. This can be done while owners are having other dry rot repaired prior to the planned painting.

Our soffit vents for the most part seem to be 2 5/8" and some homeowners have found a replacement material that would work. (See below). However, your contractor may be able to provide you alternatives that will achieve the desired results. We have also been made aware that these replacement vents may be purchased from supply shops such as Naples Lumber, Lowes and Home Depot.
